**Flood Control Project Maintenance  
Levee Inspections**

**Fall 2016 Levee Maintenance Deficiency Summary Report**

**Reclamation District No. 2107 Mossdale Island**

**Levee Inspection Report By Mile - Fall 2016**

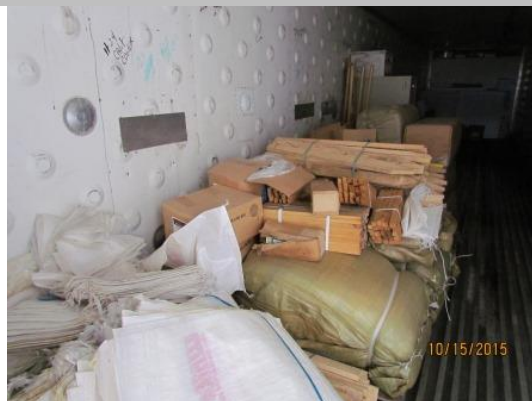
Photo 1 of 1 : FA\_2016\_RD2107\_329\_7\_20160914\_00003.jpg

LM Start		Rating **	A	Issue No.	7
LM End		Issue Type +	Ma	Location *	LS
Category	Earthen Levee		GPS Latitude/Longitude		
			Start	End	
Item	Emergency Supplies & Equipment			°	°
				°	°
DWR ID	DWR_RD2107_01_s_2013_7				
Comment Code					
Inspector Comment					
Flood fighting supplies are available on-site.

View of the flood fight emergency supplies.

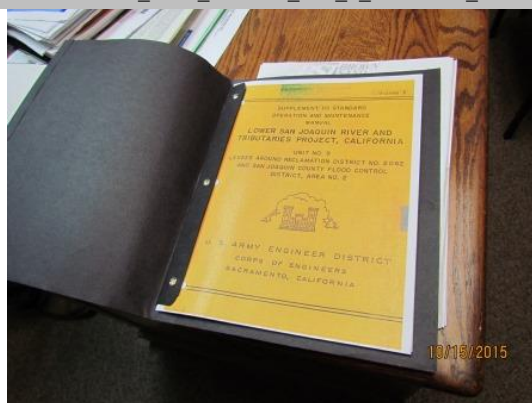
Photo 1 of 1 : FA\_2016\_RD2107\_329\_8\_20160914\_00004.jpg

LM Start		Rating **	A	Issue No.	8
LM End		Issue Type +	Ma	Location *	LS
Category	Earthen Levee		GPS Latitude/Longitude		
			Start	End	
Item	Operations & Maintenance Manuals			°	°
				°	°
DWR ID	DWR_RD2107_01_s_2013_8				
Comment Code					
Inspector Comment					
The O&M Manual is available at the LMA's office.

View of the O&amp;M Manual.

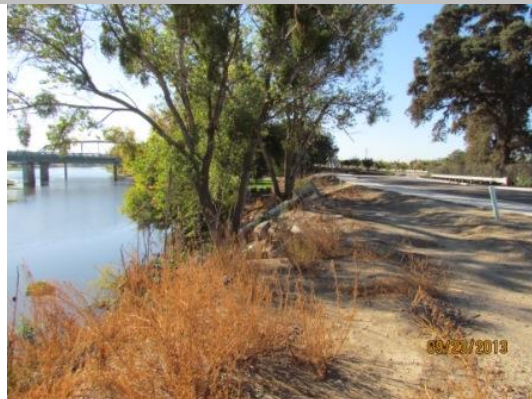
Photo 1 of 1 : FA\_2016\_RD2107\_329\_1\_20160914\_00001.jpg

LM Start	0.03	Rating **	N	Issue No.	1
LM End	0.03	Issue Type +	Ma	Location *	WS
Category	Earthen Levee			GPS Latitude/Longitude	
				Start	End
Item	Trim / Thin Trees			37.786993 °	37.786993 °
				-121.308694 °	-121.308694 °
DWR ID	DWR_RD2107_01_s_2012_1				
Comment Code					
T5 : Tree stumps.					
Inspector Comment

Photo of waterside slope. Stumps present from prior tree removal for access and visibility.

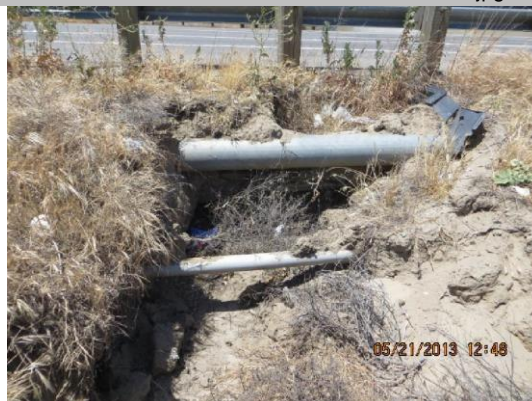
Photo 1 of 1 : UCIP\_FA\_2016\_16187\_27294.jpg

LM Start	0.23	Rating **	M	Issue No.	58
LM End	0.23	Issue Type +	En	Location *	WS
Category	Supplemental			GPS Latitude/Longitude	
				Start	End
Item	DWR UCIP Field Study			37.784586 °	37.784586 °
				-121.306837 °	-121.306837 °
DWR ID					
Comment Code					
Inspector Comment					
FS_ID:16187					
DS_ID:23107					
EP_NO: N/A					
Repair Type: Non-Urgent					
Crossing Status: Found					
UCIP Comments: No permit identified. Erosion exposed pipes on LS.					
FIELD_STRUCT_DESC: 3-inch PVC conduit 1-foot below the road surface within roadway fill over levee crown.					
FS Date: 5/22/2013

Pipes visible on LS next to roadway.

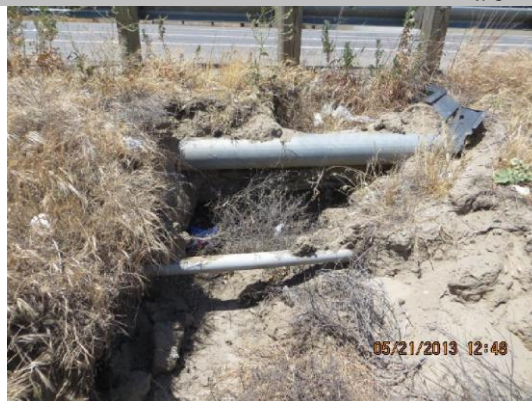
Photo 1 of 1 : UCIP\_FA\_2016\_15175\_24922.jpg

LM Start	0.23	Rating **	M	Issue No.	66
LM End	0.23	Issue Type +	En	Location *	WS
Category	Supplemental			GPS Latitude/Longitude	
				Start	End
Item	DWR UCIP Field Study			37.784586 °	37.784586 °
				-121.306837 °	-121.306837 °
DWR ID					
Comment Code					
Inspector Comment					
FS_ID:15175 DS_ID:23108 EP_NO: N/A Repair Type: Non-Urgent Crossing Status: Found UCIP Comments: No permit identified. Erosion exposed pipes on LS. FIELD_STRUCT_DESC: 8-inch steel conduit 1-foot below the road surface within roadway fill over levee crown. Visible on Upstream side of bridge. FS Date: 5/22/2013

Pipes visible on LS next to roadway.

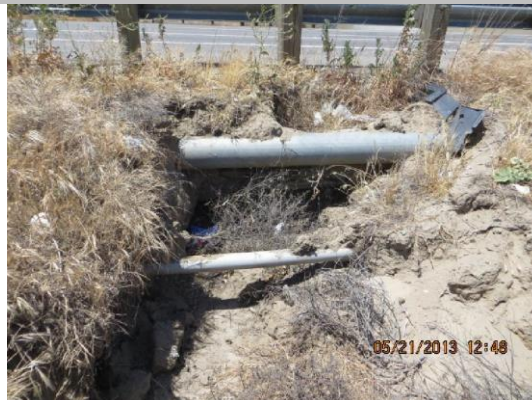
Photo 1 of 2 : UCIP\_FA\_2016\_15173\_24918.jpg

LM Start	0.23	Rating **	M	Issue No.	64
LM End	0.23	Issue Type +	En	Location *	WS
Category	Supplemental			GPS Latitude/Longitude	
				Start	End
Item	DWR UCIP Field Study			37.784586 °	37.784586 °
				-121.306837 °	-121.306837 °
DWR ID					
Comment Code					
Inspector Comment					
FS_ID:15173 DS_ID:23109 EP_NO: N/A Repair Type: Non-Urgent Crossing Status: Found UCIP Comments: No permit identified for this crossing. Erosion exposed pipes on LS. FIELD_STRUCT_DESC: 1.5-inch PVC conduit 1-foot below the road surface within roadway fill over levee crown. FS Date: 5/22/2013

Pipes visible on LS next to roadway.

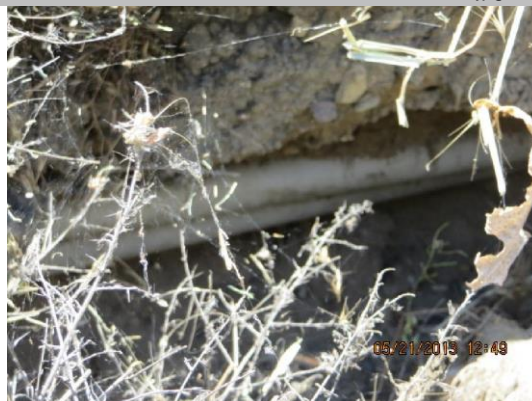
Photo 2 of 2 : UCIP\_FA\_2016\_15173\_24917.jpg

LM Start	0.23	Rating **	M	Issue No.	64 (cont)
LM End	0.23	Issue Type +	En	Location *	WS
Category	Supplemental			GPS Latitude/Longitude	
				Start	End
Item	DWR UCIP Field Study			37.784586 °	37.784586 °
				-121.306837 °	-121.306837 °
DWR ID					
Comment Code					
Inspector Comment					
FS_ID:15173 DS_ID:23109 EP_NO: N/A Repair Type: Non-Urgent Crossing Status: Found UCIP Comments: No permit identified for this crossing. Erosion exposed pipes on LS. FIELD_STRUCT_DESC: 1.5-inch PVC conduit 1-foot below the road surface within roadway fill over levee crown. FS Date: 5/22/2013

Pipes visible on LS next to roadway.

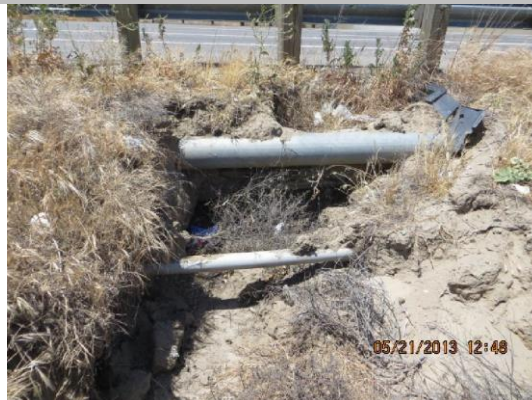
Photo 1 of 2 : UCIP\_FA\_2016\_15174\_24920.jpg

LM Start	0.23	Rating **	M	Issue No.	65
LM End	0.23	Issue Type +	En	Location *	WS
Category	Supplemental			GPS Latitude/Longitude	
				Start	End
Item	DWR UCIP Field Study			37.784586 °	37.784586 °
				-121.306837 °	-121.306837 °
DWR ID					
Comment Code					
Inspector Comment					
FS_ID:15174 DS_ID:23110 EP_NO: N/A Repair Type: Non-Urgent Crossing Status: Found UCIP Comments: No permit identified for this crossing. FIELD_STRUCT_DESC: 1.5-inch PVC conduit 1-foot below the road surface within roadway fill over levee crown. FS Date: 5/22/2013

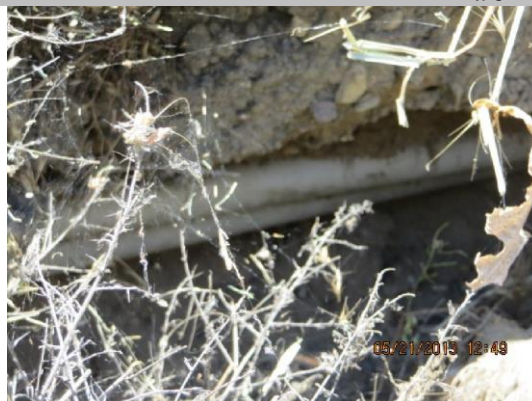
Photo 2 of 2 : UCIP\_FA\_2016\_15174\_24921.jpg

LM Start	0.23	Rating **	M	Issue No.	65 (cont)	
LM End	0.23	Issue Type +	En	Location *	WS	
Category	Supplemental			GPS Latitude/Longitude		
				Start		End
Item	DWR UCIP Field Study			37.784586 °		37.784586 °
				-121.306837 °		-121.306837 °
DWR ID						
Comment Code						
Inspector Comment						
FS_ID:15174						
DS_ID:23110						
EP_NO: N/A						
Repair Type: Non-Urgent						
Crossing Status: Found						
UCIP Comments: No permit identified for this crossing.						
FIELD_STRUCT_DESC: 1.5-inch PVC conduit 1-foot below the road surface within roadway fill over levee crown.						
FS Date: 5/22/2013

Pipes visible on LS next to roadway.

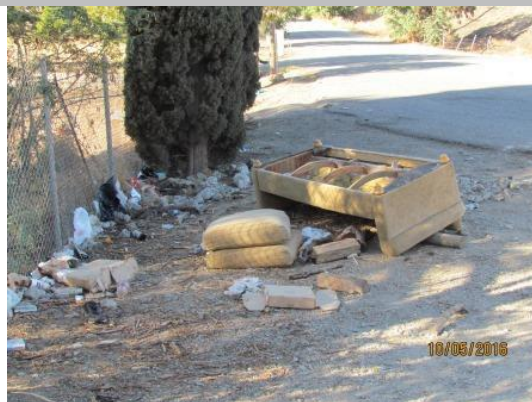
Photo 1 of 1 : FA\_2016\_RD2107\_329\_18\_20161006\_00027.jpg

LM Start	0.25	Rating **	M	Issue No.	18
LM End	0.25	Issue Type +	Ma	Location *	LS
Category	Earthen Levee			GPS Latitude/Longitude	
				Start	End
Item	Encroachments			37.784372 °	37.784372 °
				-121.306647 °	-121.306647 °
DWR ID	DWR_RD2107_01_f_2016_18				
Comment Code					
GA : Garbage					
Inspector Comment

View of the garbage on the landside levee slope.

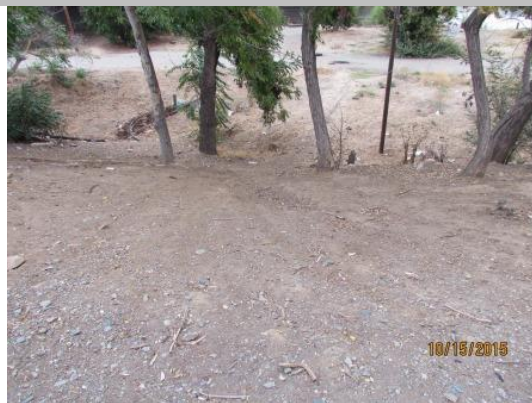
Photo 1 of 1 : FA\_2016\_RD2107\_329\_19\_20160914\_00006.jpg

LM Start	0.26	Rating **	A/W	Issue No.	19
LM End	0.26	Issue Type +	Ma	Location *	WS
Category	Earthen Levee			GPS Latitude/Longitude	
				Start	End
Item	Slope Stability			37.784300 °	37.784300 °
				-121.306488 °	-121.306488 °
DWR ID	DWR_RD2107_01_f_2015_19				
Comment Code					
S2 : Repair the levee slope damaged by foot traffic and prevent access where possible.					
Inspector Comment

View of the tracks on the waterside levee slope.

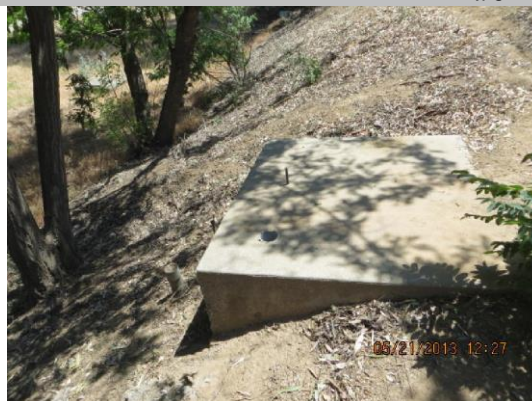
Photo 1 of 1 : UCIP\_FA\_2016\_16188\_27296.jpg

LM Start	0.27	Rating **	M	Issue No.	59
LM End	0.27	Issue Type +	En	Location *	WS
Category	Supplemental			GPS Latitude/Longitude	
				Start	End
Item	DWR UCIP Field Study			37.784194 °	37.784194 °
				-121.306353 °	-121.306353 °
DWR ID					
Comment Code					
Inspector Comment					
FS_ID:16188 DS_ID:19055 EP_NO: 12101B Repair Type: Non-Urgent Crossing Status: Found UCIP Comments: Appears abandoned and should be done so properly. FIELD_STRUCT_DESC: 4" electrical conduit through the levee 2.5 feet below the crown. Distribution panel on a 5-foot by 6-foot concrete pad on the WS shoulder (Permit No 12101B, 1979). FS Date: 5/21/2013

5X5 concrete pad with exposed electrical conduit on WS shoulder.

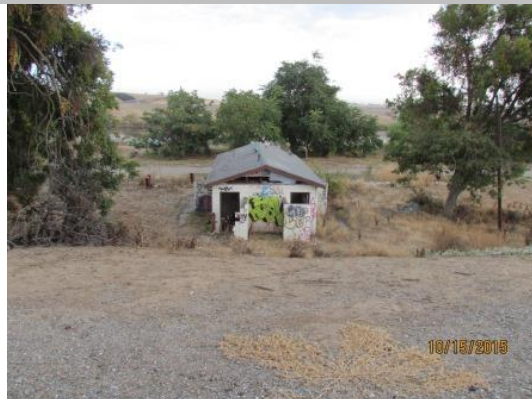
Photo 1 of 1 : FA\_2016\_RD2107\_329\_20\_20160914\_00007.jpg

View of the building in the floodway.

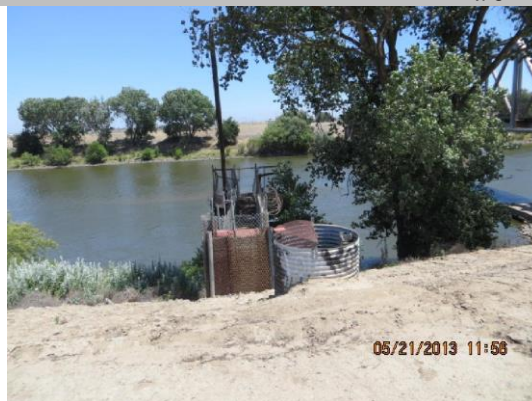
Photo 1 of 2 : UCIP\_FA\_2016\_13684\_22411.jpg

LM Start	0.68	Rating **	M	Issue No.	63
LM End	0.68	Issue Type +	En	Location *	WS
Category	Supplemental			GPS Latitude/Longitude	
				Start	End
Item	DWR UCIP Field Study			37.779486 °	37.779486 °
				-121.301961 °	-121.301961 °
DWR ID					
Comment Code					
Inspector Comment					
FS_ID:13684 DS_ID:19036 EP_NO: N/A Repair Type: Non-Urgent Crossing Status: Found UCIP Comments: Wooden walkway to pump on platform is in disrepair and may be a hazard. FIELD_STRUCT_DESC: 1 of 2: 14-inch pipe through the levee 17.0 feet below the crown. Pump on pile structure in the stream. Walkway to pump. Slide gate in 48-inch CMP riser on WS shoulder. 36-inch concrete standpipe at the landward toe. Service pole and circuit panel on landward toe. Originally included in O&M manual, 1964. FS Date: 5/21/2013

Pier and 48-inch CMP riser on WS shoulder

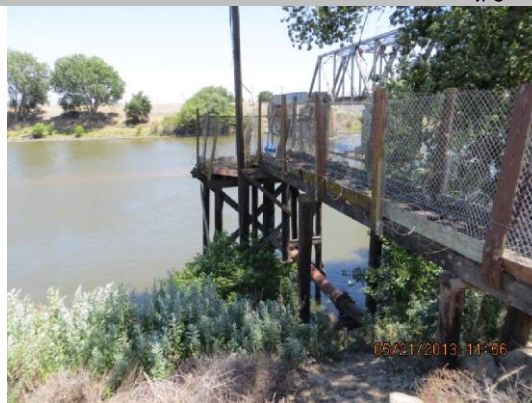
Photo 2 of 2 : UCIP\_FA\_2016\_13684\_22410.jpg

Walkway to pump on pier at WS.

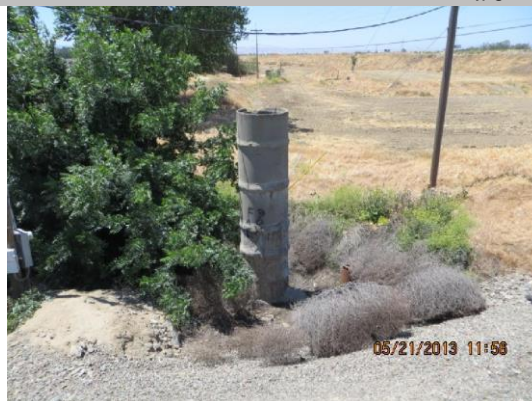
Photo 1 of 2 : UCIP\_FA\_2016\_13883\_22821.jpg

LM Start	0.70	Rating **	M	Issue No.	60
LM End	0.70	Issue Type +	En	Location *	WS
Category	Supplemental			GPS Latitude/Longitude	
				Start	End
Item	DWR UCIP Field Study			37.779209 °	37.779209 °
				-121.301973 °	-121.301973 °
DWR ID					
Comment Code					
Inspector Comment					
FS_ID:13883					
DS_ID:19039					
EP_NO: N/A					
Repair Type: Non-Urgent					
Crossing Status: Found					
UCIP Comments: Slide gate missing actuator inside 55-inch CMP riser.					
FIELD_STRUCT_DESC: 14-inch pipe through the levee, 15.0 feet					
below the crown. Pipe likely runs from 36-inch concrete standpipe on					
LS to outlet on WS toe. Portion of the discharge line from the pump at					
Levee Mile 0.68. 55-inch CMP riser with slide gate on LS shoulder.					
Originally included in O&M manual, 1964.					
FS Date: 5/21/2013

36-inch concrete standpipe on LS toe.

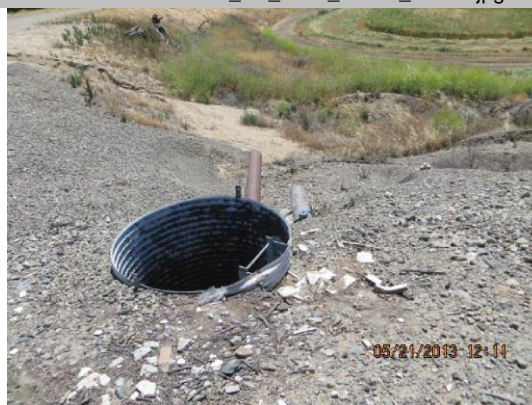
Photo 2 of 2 : UCIP\_FA\_2016\_13883\_22822.jpg

55-inch CMP riser with slide gate (no handle) on LS shoulder. 14-inch and 12-inch pipe visible on LS toe.

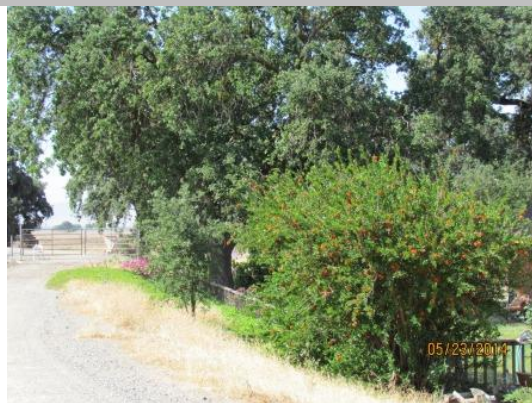
Photo 1 of 1 : FA\_2016\_RD2107\_329\_17\_20160914\_00005.jpg

View of landscape planting on landside levee slope and a 3-ft yard fence at the levee toe.

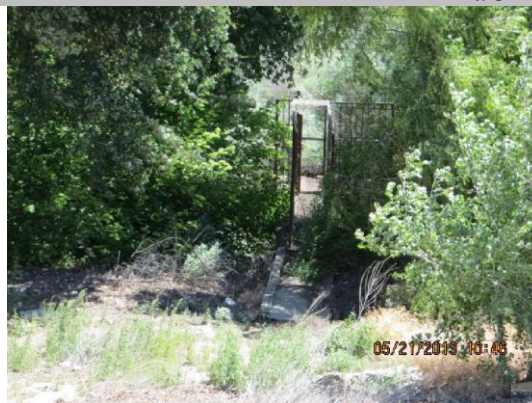
Photo 1 of 2 : UCIP\_FA\_2016\_13650\_22341.jpg

LM Start	1.47	Rating **	M	Issue No.	61	
LM End	1.47	Issue Type +	En	Location *	LS	
Category	Supplemental			GPS Latitude/Longitude		
				Start	End	
Item	DWR UCIP Field Study			37.771735 °	37.771735 °	
				-121.304847 °	-121.304847 °	
DWR ID						
Comment Code						
Inspector Comment						
FS_ID:13650						
DS_ID:19040						
EP_NO: N/A						
Repair Type: Non-Urgent						
Crossing Status: Found						
UCIP Comments: No pump. Appears abandoned. Large hole under pipe on WS slope from animal activity.						
FIELD_STRUCT_DESC: 1 of 2: 18-inch PVC irrigation pipe through the levee 2.5 feet below the crown. Pump on pile structure in the stream.						
Walkway to the pump. Originally included O&M manual, 1964.						
FS Date: 5/21/2013

Pumping plant on metal pier on WS toe.

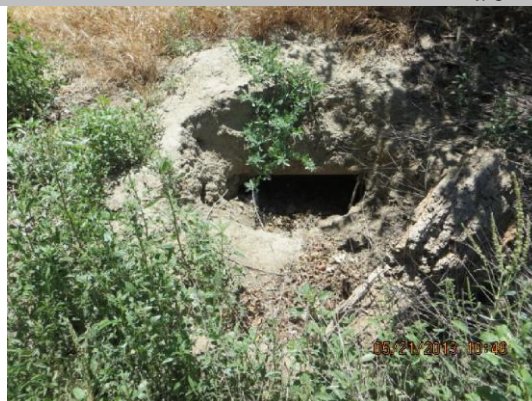
Photo 2 of 2 : UCIP\_FA\_2016\_13650\_22340.jpg

LM Start	1.47	Rating **	M	Issue No.	61 (cont)	
LM End	1.47	Issue Type +	En	Location *	LS	
Category	Supplemental			GPS Latitude/Longitude		
				Start	End	
Item	DWR UCIP Field Study			37.771735 °	37.771735 °	
				-121.304847 °	-121.304847 °	
DWR ID						
Comment Code						
Inspector Comment						
FS_ID:13650 DS_ID:19040 EP_NO: N/A Repair Type: Non-Urgent Crossing Status: Found UCIP Comments: No pump. Appears abandoned. Large hole under pipe on WS slope from animal activity. FIELD_STRUCT_DESC: 1 of 2: 18-inch PVC irrigation pipe through the levee 2.5 feet below the crown. Pump on pile structure in the stream. Walkway to the pump. Originally included O&M manual, 1964. FS Date: 5/21/2013

Large hole under pipe on WS slope.

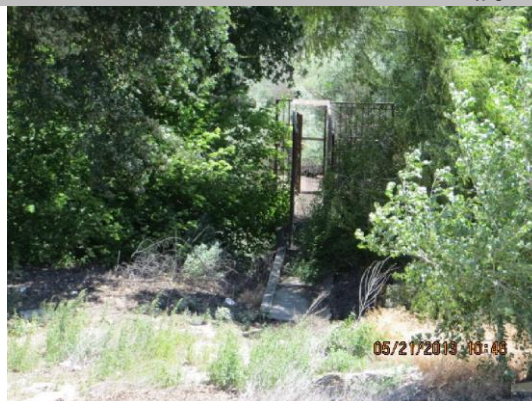
Photo 1 of 2 : UCIP\_FA\_2016\_15179\_24935.jpg

LM Start	1.47	Rating **	M	Issue No.	67
LM End	1.47	Issue Type +	En	Location *	LS
Category	Supplemental			GPS Latitude/Longitude	
				Start	End
Item	DWR UCIP Field Study			37.771735 °	37.771735 °
				-121.304847 °	-121.304847 °
DWR ID					
Comment Code					
Inspector Comment					
FS_ID:15179 DS_ID:23106 EP_NO: N/A Repair Type: Non-Urgent Crossing Status: Found UCIP Comments: Pipe open on WS toe at the pump on pier. Pipe abandoned and should be done so properly. FIELD_STRUCT_DESC: 16-inch steel irrigation pipe through the levee 2.5 feet below the crown. Pump on pile structure in the stream. Walkway to the pump. FS Date: 5/21/2013

Metal pier on WS slope.

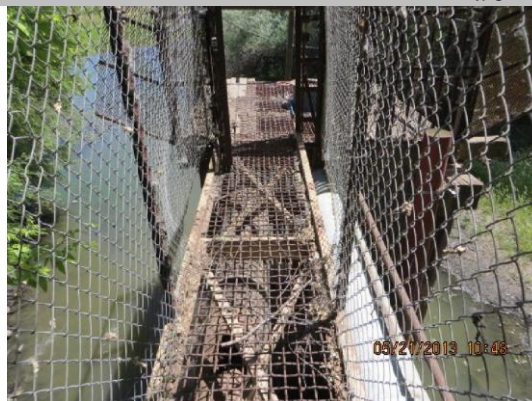
Photo 2 of 2 : UCIP\_FA\_2016\_15179\_24934.jpg

LM Start	1.47	Rating **	M	Issue No.	67 (cont)	
LM End	1.47	Issue Type +	En	Location *	LS	
Category	Supplemental			GPS Latitude/Longitude		
				Start	End	
Item	DWR UCIP Field Study			37.771735 °	37.771735 °	
				-121.304847 °	-121.304847 °	
DWR ID						
Comment Code						
Inspector Comment						
FS_ID:15179 DS_ID:23106 EP_NO: N/A Repair Type: Non-Urgent Crossing Status: Found UCIP Comments: Pipe open on WS toe at the pump on pier. Pipe abandoned and should be done so properly. FIELD_STRUCT_DESC: 16-inch steel irrigation pipe through the levee 2.5 feet below the crown. Pump on pile structure in the stream. Walkway to the pump. FS Date: 5/21/2013

Pipe visible under metal walkway on WS slope.

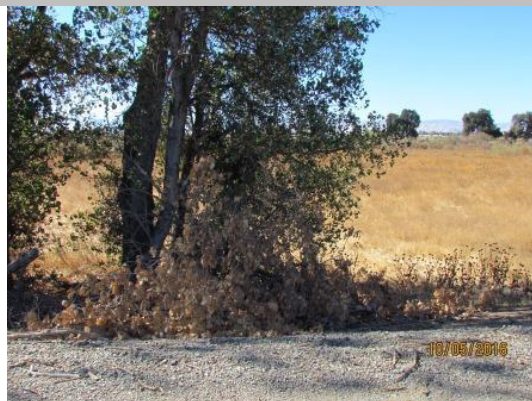
Photo 1 of 1 : FA\_2016\_RD2107\_330\_8\_20161006\_00012.jpg

View of the prunings of the waterside levee slope.

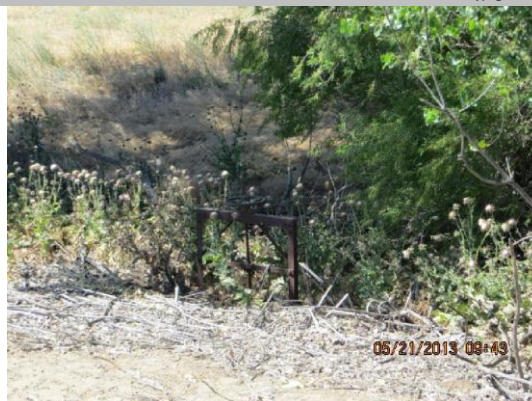
Photo 1 of 2 : UCIP\_FA\_2016\_13637\_22299.jpg

LM Start	0.27	Rating **	M	Issue No.	12
LM End	0.27	Issue Type +	En	Location *	WS
Category	Supplemental			GPS Latitude/Longitude	
				Start	End
Item	DWR UCIP Field Study			37.762613 °	37.762613 °
				-121.313480 °	-121.313480 °
DWR ID					
Comment Code					
Inspector Comment					
FS_ID:13637 DS_ID:19057 EP_NO: N/A Repair Type: Non-Urgent Crossing Status: Found UCIP Comments: Pipe filled in with soil around outlet and not visible on LS. Appears abandoned and should be done so properly. FIELD_STRUCT_DESC: *ABANDONED* 16-inch steel storm drain pipe 16-feet below the crown with slide gate on WS toe. Originally included in O&M manual, 1964. FS Date: 5/21/2013

Slide gate visible on WS toe.

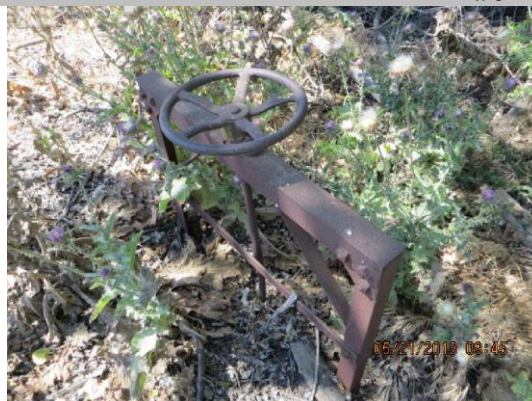
Photo 2 of 2 : UCIP\_FA\_2016\_13637\_22298.jpg

LM Start	0.27	Rating **	M	Issue No.	12 (cont)	
LM End	0.27	Issue Type +	En	Location *	WS	
Category	Supplemental			GPS Latitude/Longitude		
				Start	End	
Item	DWR UCIP Field Study			37.762613 °	37.762613 °	
				-121.313480 °	-121.313480 °	
DWR ID						
Comment Code						
Inspector Comment						
FS_ID:13637						
DS_ID:19057						
EP_NO: N/A						
Repair Type: Non-Urgent						
Crossing Status: Found						
UCIP Comments: Pipe filled in with soil around outlet and not visible on						
LS. Appears abandoned and should be done so properly.						
FIELD_STRUCT_DESC: *ABANDONED* 16-inch steel storm drain pipe						
16-feet below the crown with slide gate on WS toe. Originally included						
in O&M manual, 1964.						
FS Date: 5/21/2013

Slide gate visible on WS toe.

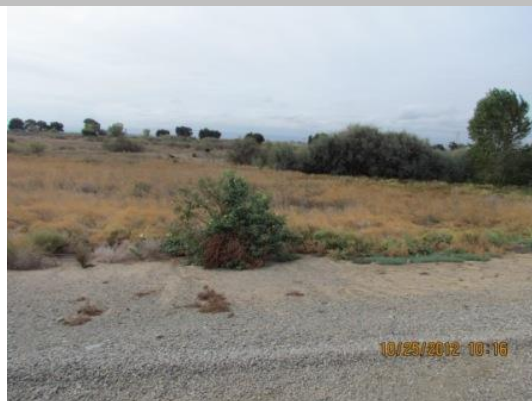
Photo 1 of 1 : FA\_2016\_RD2107\_330\_4\_20160914\_00001.jpg

LM Start	0.51	Rating **	A/W	Issue No.	4
LM End	0.51	Issue Type +	Ma	Location *	WS
Category	Earthen Levee			GPS Latitude/Longitude	
				Start	End
Item	Vegetation			37.764780 °	37.764780 °
				-121.316717 °	-121.316717 °
DWR ID	DWR_RD2107_02_s_2012_4				
Comment Code					
V4 : Elderberries are blocking visibility and flood fight capability.					
Inspector Comment					
Elderberry bush on waterside. Shrub is more than 20ft down the slope.

Elderberry located on waterside slope.

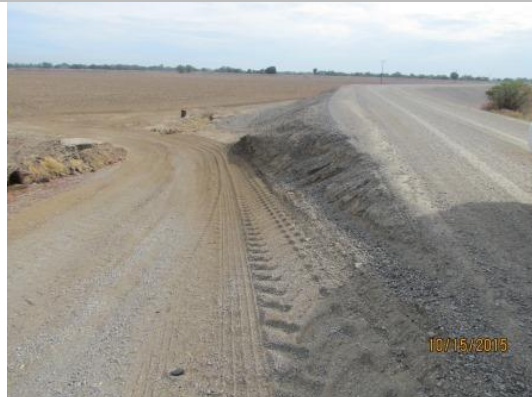
Photo 1 of 1 : FA\_2016\_RD2107\_330\_9\_20160914\_00002.jpg

LM Start	0.54	Rating **	M	Issue No.	9
LM End	0.54	Issue Type +	Ma	Location *	LS
Category	Earthen Levee			GPS Latitude/Longitude	
				Start	End
Item	Slope Stability			37.764838 °	37.764838 °
				-121.317318 °	-121.317318 °
DWR ID	DWR_RD2107_02_f_2015_9				
Comment Code					
S1 : Repair slope instability.					
Inspector Comment					
Add appropriate fill and compact the slope.

View of the vertical cut on the landside levee slope.

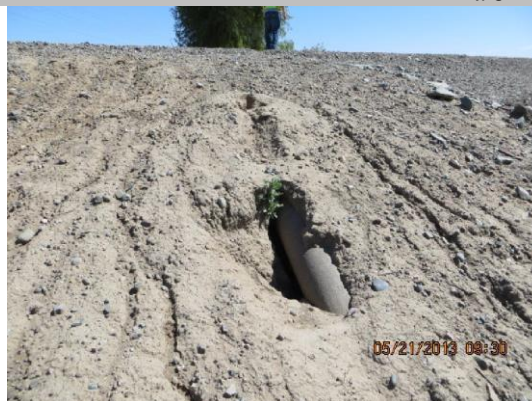
Photo 1 of 2 : UCIP\_FA\_2016\_13636\_22296.jpg

LM Start	0.54	Rating **	M	Issue No.	11
LM End	0.54	Issue Type +	En	Location *	LS
Category	Supplemental			GPS Latitude/Longitude	
				Start	End
Item	DWR UCIP Field Study			37.764832 °	37.764832 °
				-121.317405 °	-121.317405 °
DWR ID					
Comment Code					
Inspector Comment					
FS_ID:13636					
DS_ID:19058					
EP_NO: 13161					
Repair Type: Non-Urgent					
Crossing Status: Found					
UCIP Comments: Some erosion along pipe alignment on WS slope.					
FIELD_STRUCT_DESC: 10-inch steel storm drain pipe through the					
levee 5-feet below the crown. Pump located on 36-inch concrete					
standpipe at LS toe. A PVC pipe runs parallel to waterward toe to train					
tracks. Air relief valve on waterward shoulder (Permit No. 13161, 1981).					
FS Date: 5/21/2013

Erosion along pipe alignment on WS slope.

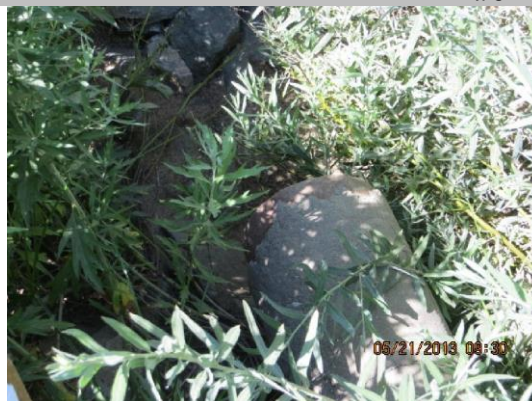
Photo 2 of 2 : UCIP\_FA\_2016\_13636\_22295.jpg

LM Start	0.54	Rating **	M	Issue No.	11 (cont)	
LM End	0.54	Issue Type +	En	Location *	LS	
Category	Supplemental			GPS Latitude/Longitude		
				Start	End	
Item	DWR UCIP Field Study			37.764832 °	37.764832 °	
				-121.317405 °	-121.317405 °	
DWR ID						
Comment Code						
Inspector Comment						
FS_ID:13636 DS_ID:19058 EP_NO: 13161 Repair Type: Non-Urgent Crossing Status: Found UCIP Comments: Some erosion along pipe alignment on WS slope. FIELD_STRUCT_DESC: 10-inch steel storm drain pipe through the levee 5-feet below the crown. Pump located on 36-inch concrete standpipe at LS toe. A PVC pipe runs parallel to waterward toe to train tracks. Air relief valve on waterward shoulder (Permit No. 13161, 1981). FS Date: 5/21/2013

Pipe at outlet.

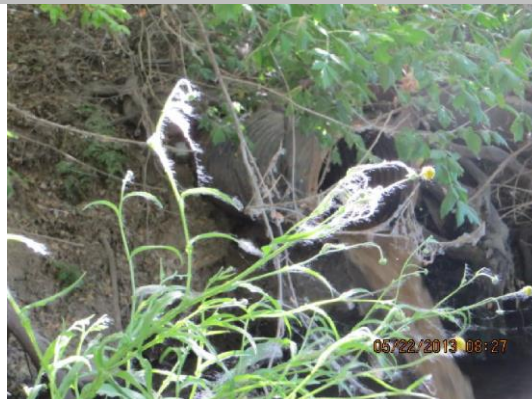
Photo 1 of 2 : UCIP\_FA\_2016\_50762\_22441.jpg

FS\_ID:50762  
DS\_ID:19056  
EP\_NO: 2966  
Repair Type: Urgent  
Crossing Status: Found  
UCIP Comments: 11/16/2016 Visible hole through pipe visible on WS end. Sink hole present at the LS ditch. Evidence of pipe repair visible on LS (see photos) however, no permit was found to document the work. Need to contact owner to determine permit authorizing work. Due to the hole in the pipe recommend internal inspection of the pipe through the levee to determine pipe integrity. (O. Magana - DWR UCIP)05/22/2013 Headwall around pipe at LS toe is failing and should be shored up. Flap gate propped open and should be returned to normal function. (W. Wylie - DWR UCIP)  
FIELD\_STRUCT\_DESC: 24-inch steel drain pipe through the levee 14 feet below the crown. Flap gate installed on the waterward end of the pipe and two standard reinforced concrete cutoff walls were placed around the pipe in line with the levee shoulders (Permit No. 2966, 1958 - Dell'Osso Brothers).

Pipe visible on WS toe with Flap gate open.

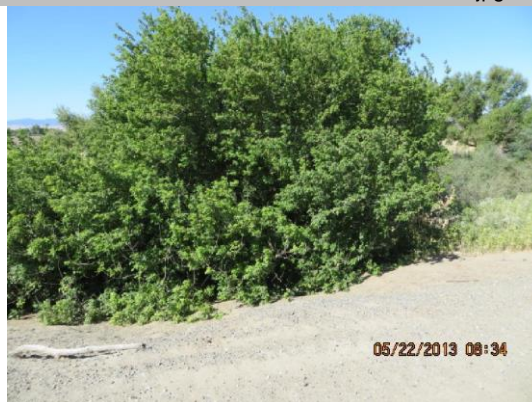
Photo 2 of 2 : UCIP\_FA\_2016\_50762\_22440.jpg

Pipes visible under foliage on WS toe.
